NATIONAL PROGRAM FOR INSPECTION OF NON-FEDERAL DAMS
WEST SIDE DAM (CT 004..(U) CORPS OF ENGINEERS WALTHAM
MA NEW ENGLAND DIV FEB 81

REPORT DOCUMENTATION PAGE		READ INSTRUCTIONS BEFORE COMPLETING FORM
1. REPORT NUMBER CT 00484	2. GOVT ACCESSION NO.	3. RECIPIENT'S CATALOG NUMBER
4. TITLE (and Subtitle) West Side Dam NATIONAL PROGRAM FOR INSPECTION OF NON-FEDERAL DAMS		5. TYPE OF REPORT & PERIOD COVERED INSPECTION REPORT

WEST SIDE DAM
BLACKBERRY RIVER
NORFOLK, CONNECTICUT
CT 00484
17 NOVEMBER '80

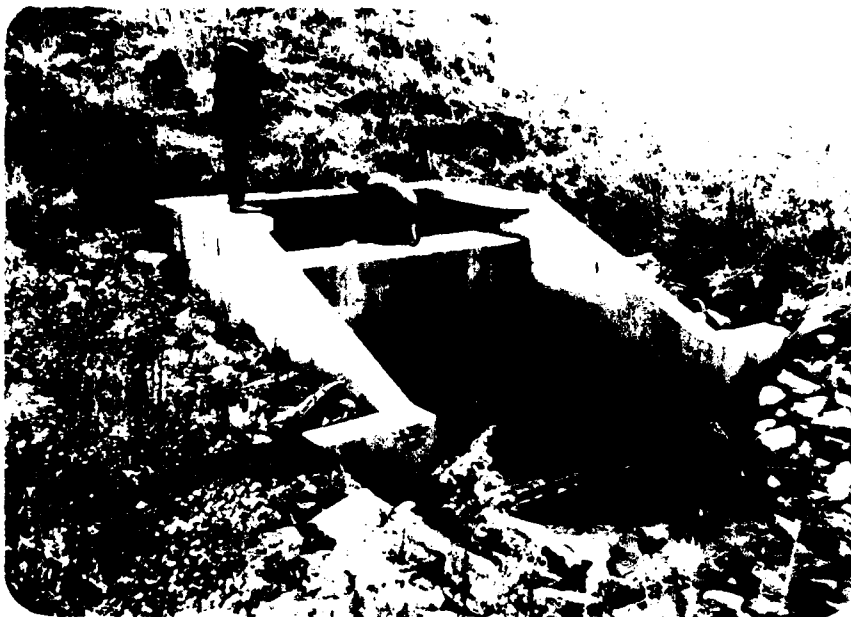
PHOTO NO. 7

The appurtenant structures consist of the principal spillway and outlet works and the emergency spillway. The inlet structure is a reinforced concrete drop inlet with a galvanized steel trash rack, Photo 5, all in good condition. Flashboards at the upstream end allow for draining the sediment basin. Sediment was visible almost to the top of the boards at the time of inspection, Photo 6. The inlet structure discharges through a 36-inch prestressed concrete steel cylinder pipe, which was not observed, to a reinforced concrete energy dissipator of the impact box type, Photo 7. The concrete was in good condition. There was quite a bit of stone riprap in the energy dissipator. The riprap around the energy dissipator has settled or may have been tossed into the dissipator by vandals. The toe drains discharge through the walls of the energy dissipator. The openings of the energy dissipator did not have any protective bar screens or fence.

ENERGY DISSIPATOR. NOTE TOE DRAIN DISCHARGE,
ROCKS IN THE DISSIPATOR AND UNMOWED GRASS ON EMBANKMENT.
